First Level Appeal
Atascadero City Hall

City of Atascadero

February 1, 2008

**SUBJECT: Atascadero City Hall
First Level Appeal, PW 229-1
FEMA-1505-DR-CA, P.A. ID 079-03064-00
City of Atascadero**

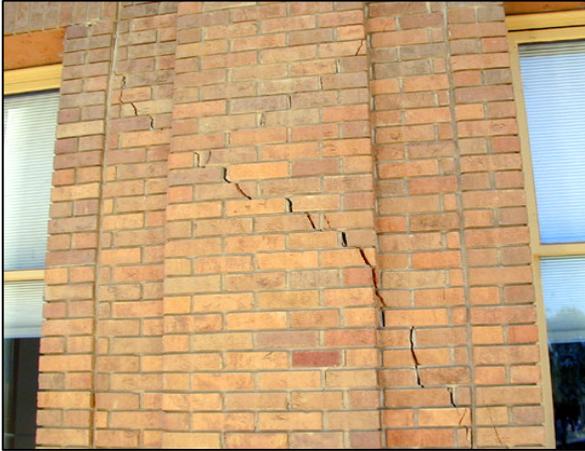
- At the 1st through 3rd floors, the URM infill walls in both directions have very large cracks all the way through three wythes of brick. (Figures V and VI).¹⁶
- At the 4th and 5th floors, the URM vertical load bearing walls are cracked completely through all three layers of brick and the walls are tilting/leaning away from supporting floor structure. Large sections of the walls are on the verge of collapse (Figure VII).¹⁷
- At the 6th level, large portions of the single wythe brick URM walls collapsed leaving only 1 x 6 wood framing to support the roof (Figure VIII).¹⁸

Figure V. Diagonal cracking through bricks.

- At floors 1 through 3, install supporting steel to the existing damaged URM infill walls and concrete floors. Place a four (4) inch thick shotcrete overlay on the interior face of the damaged masonry walls and carry the new vertical loads down to the strengthened foundation.

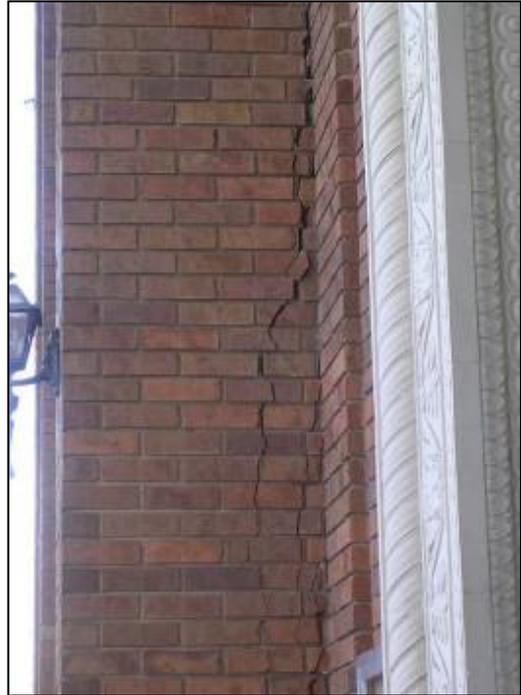
Figure VI. Cracking through bricks at corners.

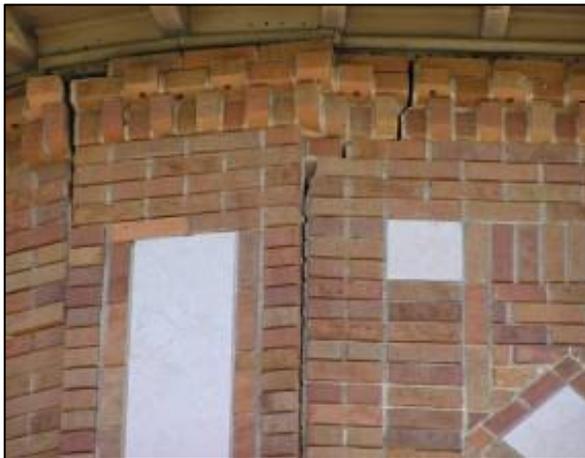
Figure VII. Fifth floor bulging sections of wall.

- At floors 4 and 5, repair surface of damaged URM walls and apply a carbon fiber overlay set in an epoxy matrix to the walls. Anchor the overlay to the walls and floors below.

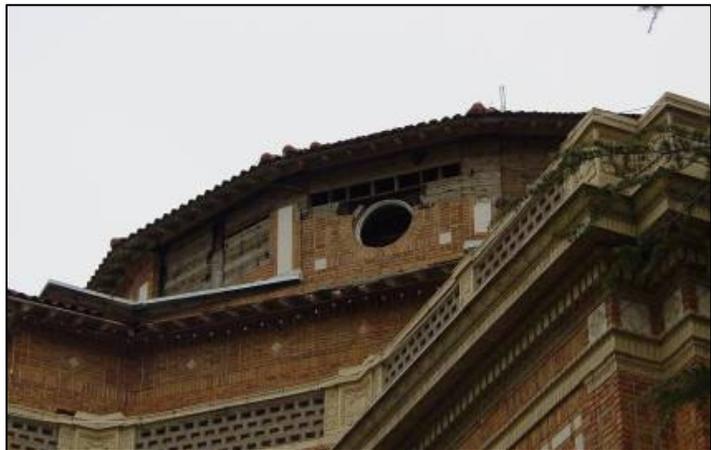
Figure VIII. Collapse of sixth floor URM walls.

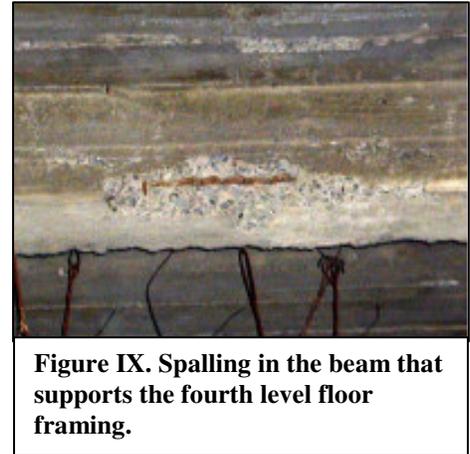
- Given the level and pattern of damage in the remainder of the building, the City wholly expects that there will be cracking and spalling on the 2nd and 3rd floors level diaphragms similar to what is seen on the 1st and 4th floors.⁹⁷

Figure IX. Spalling in the beam that supports the fourth level floor framing.

- Epoxy inject earthquake-related cracks in concrete floors and re-point and clean exterior walls.
- Repair or replace the HVAC, electrical and plumbing systems, reconstruct interior partitions, reconstruct/restore interior finishes, lighting, and landscaping.

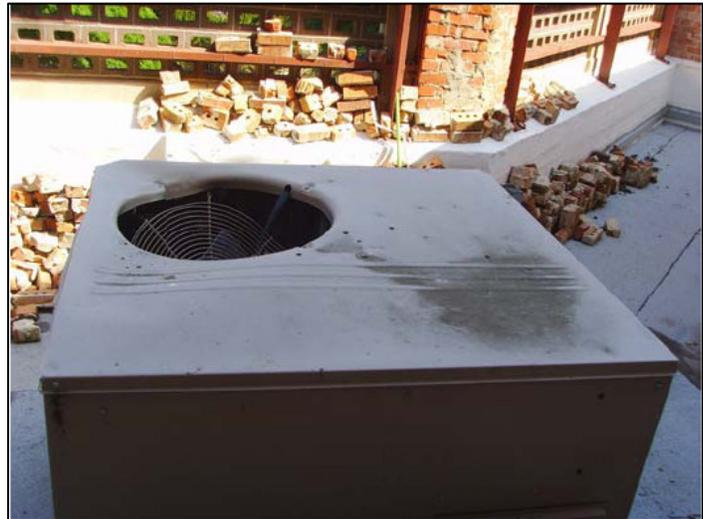
- Immediately after the quake, continued operation was impossible because of the threat of broken water and gas pipes. The system had to be shut down, deteriorated quickly, and became inoperable.
- The earthquake damaged the building so severely that it was hazardous for workers to enter the building to perform protection, repair and maintenance work.
- After the earthquake the City extensively reviewed the work necessary to restart and run the system. The City Engineer and Risk Manager concluded that a system restart was too high a risk for workers.
- Repair of the system was considered as a component of repair of the earthquake damage to the building that would occur during construction. After expert consultation, it was concluded that replacement of the system would be a cost effective alternative to repair.

Figure X. Damaged roof-top AC unit.

In response to FEMA’s request for the City to document and quantify earthquake damage, the City hired Gayner Engineers to re-examine the HVAC system. Gayner found that the roof-top package AC unit had been severely damaged by falling brick, the closed circuit cooler, boiler, pumps and controls at the central plant were irreparable and need replacement, and 40 heat pumps and associated controllers on the 1st through 4th floors also were beyond repair and required replacement. Additionally, the entire system

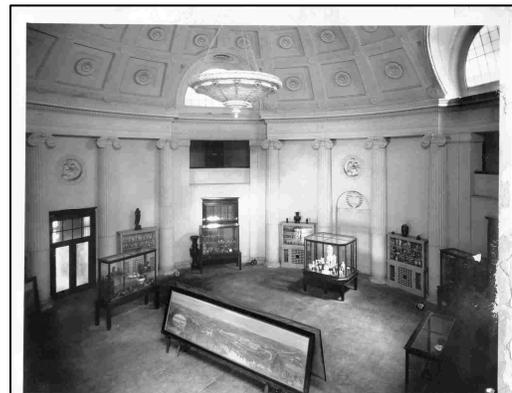
Figure XI. City Hall Lower Rotunda.

The City disagrees with FEMA's omission of 1,354 square feet of painting in the lower rotunda from the PW scope of work.

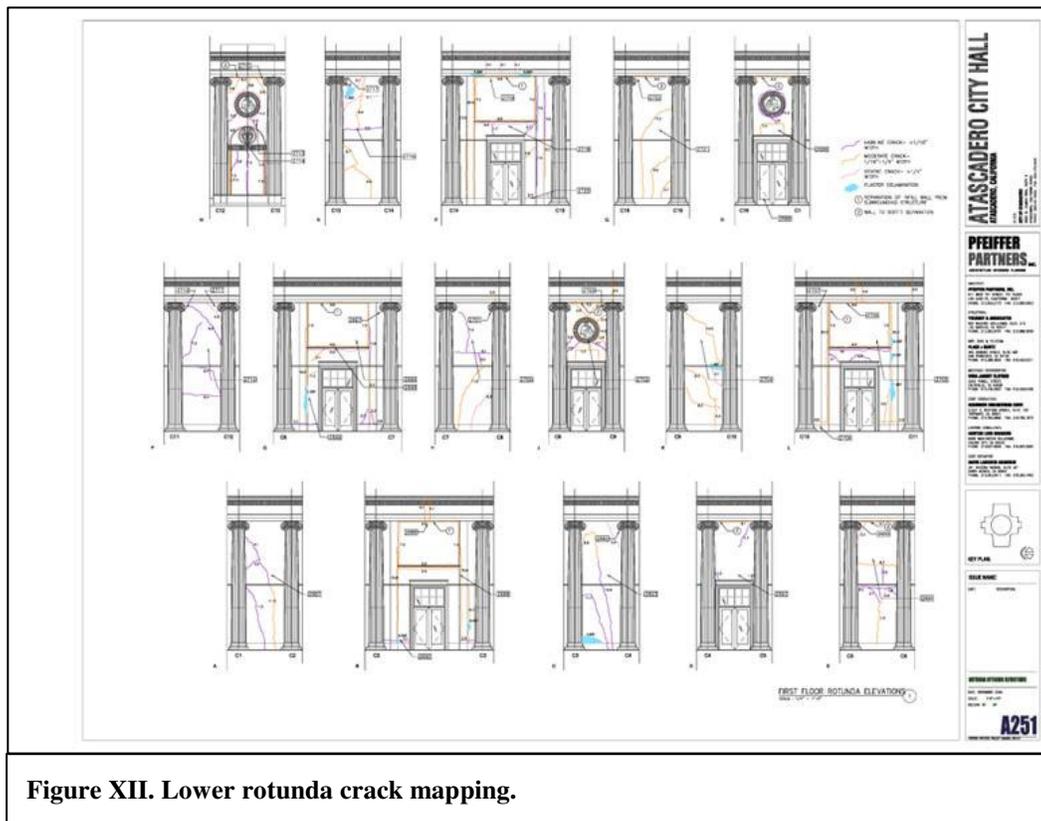
- In Volume III of the City's Damage Assessment, Sheet A251, the round room is broken down into 16 manageable segments of wall. (Figure XII)¹²⁰ Each segment of the wall has documented cracks, indicating that all 5,775 square feet of the round room should be eligible for painting in the repair category.

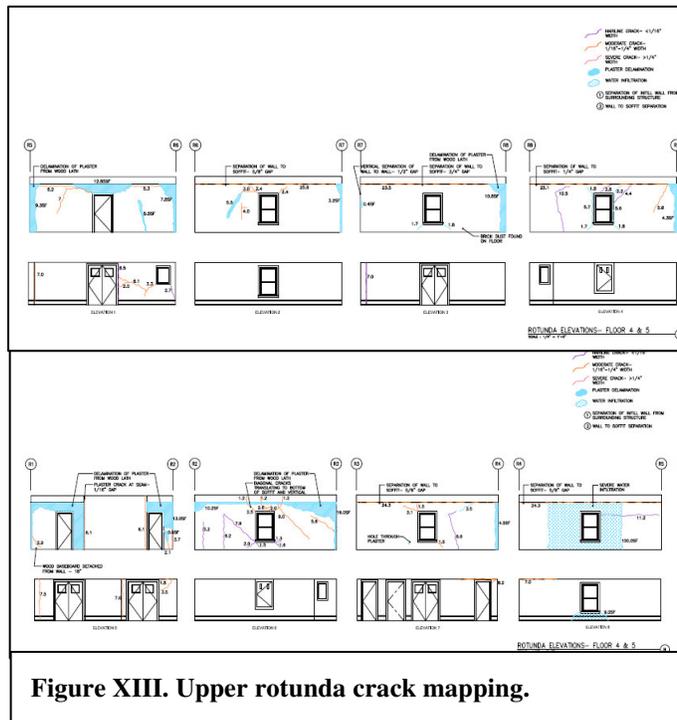
Figure XIII. Upper rotunda crack mapping.

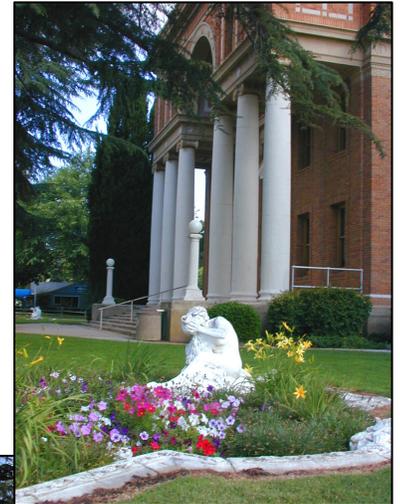
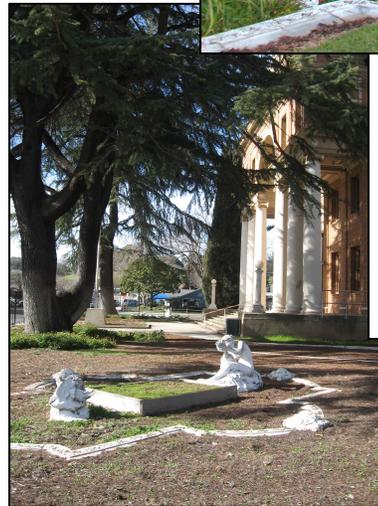
- While funding for seeding is helpful, it will not restore the other aspects of the historic fabric of the setting of this landmark to its pre-disaster condition.

Figure XIV.
City Hall
sitescape
before and
after the San
Simeon
earthquake.
