First Level Appeal
Atascadero City Hall

City of Atascadero

February 1, 2008

**SUBJECT: Atascadero City Hall
First Level Appeal, PW 229-1
FEMA-1505-DR-CA, P.A. ID 079-03064-00
City of Atascadero**

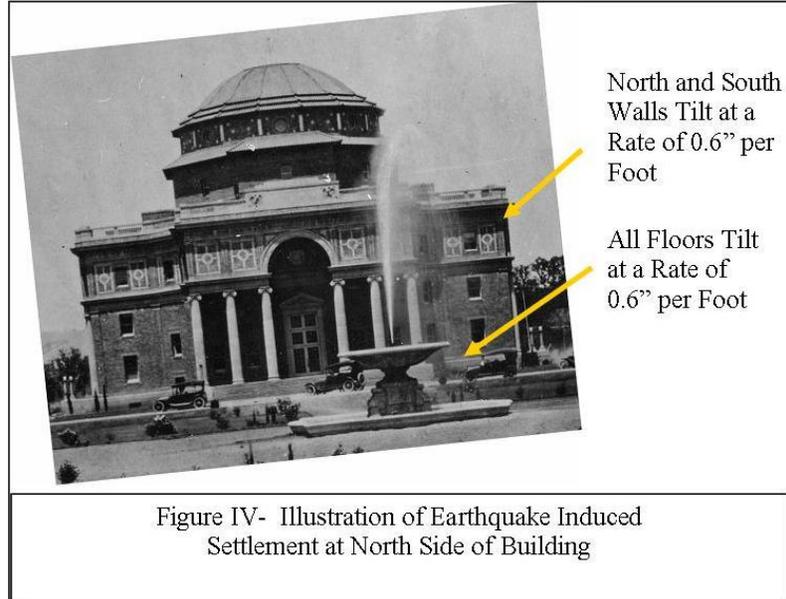
- The site experienced significant settlement caused by sub-surface soil liquefaction due to the earthquake¹⁴. All the floors share the same angle of slope to the north and all the walls share the same inclination from vertical which indicates that the building settled towards the north as a whole and in a uniform manner.¹⁵
